INVESTIGATION OF HYDROTEST FAILURE
OF THIOKOL CHEMICAL CORPORATION
260-INCH-DIAMETER SL-1 MOTOR CASE

by John E. Srawley and Jack B. Esgar

Lewis Research Center

Start
The Thiokol Chemical Corporation 260-inch-diameter SL-1 ^A motor case failed during hydrotest at a pressure of 542 pounds per square inch, which was about 56 percent of proof pressure. The motor case was constructed of 250 grade ^{FEB} maraging steel plate joined mostly by submerged arc automatic welding. An investigation of the failure was conducted by a Committee composed of members from Industry and Government. Investigation showed that the failure originated from a defect that was not detected by nondestructive testing techniques prior to aging. Nondestructive testing was not conducted between aging and hydrotest. The defect causing the failure was in the heat-affected zone of a longitudinal submerged arc weld on the cylindrical section of the motor case. The area where the defect was located had been repaired by a manual gas-tungsten-arc (TIG) weld. The defect, which was submerged within the vessel wall and oriented longitudinally, was approximately 1.4 inches long and had a width of about 0.10 inch. Four other

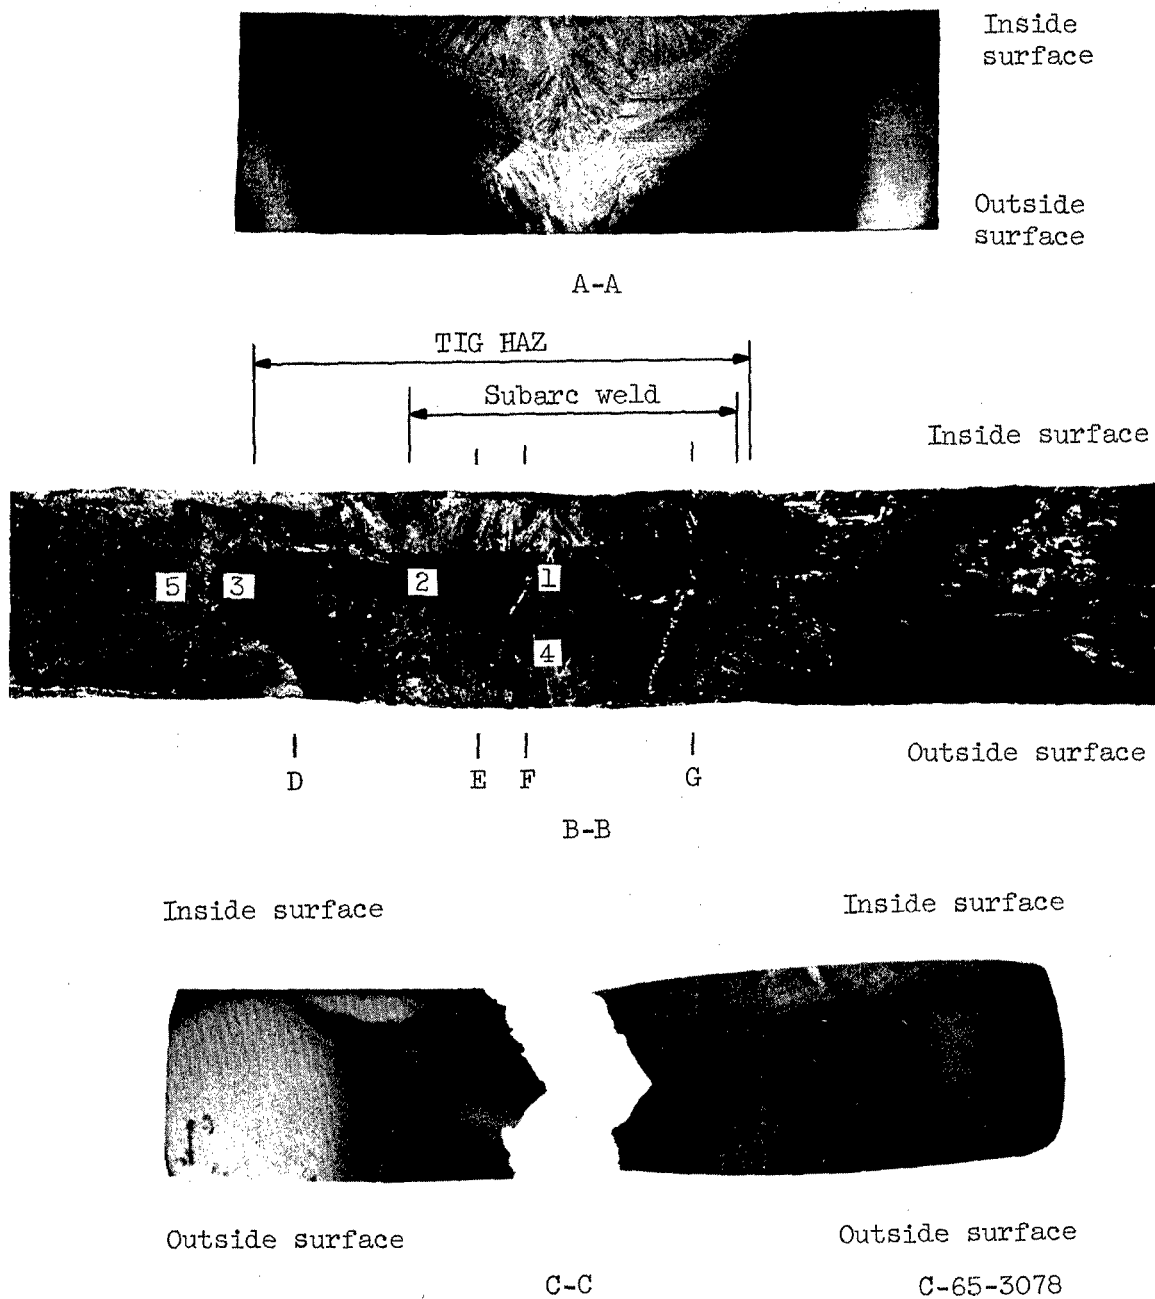
Figure 26. - Photomacrographs of black defect region (see fig. 25). $\times 1.5$.
